TSD-12-015

August, 2012

Customer Complaints for Vibration -Tire/Rim Slip-

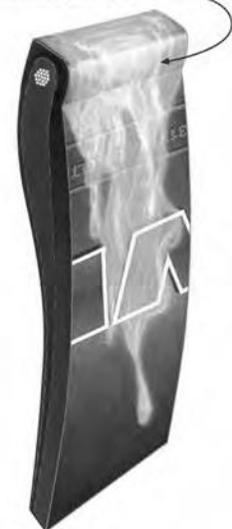
INCORRECT APPLICATION OF LUBRICANT

The main cause of tire/wheel slip is excessive use of tire lubricant (shown on the right) on the tire beads and rim. Excessive lubricant reduces friction between the tire bead and the wheel, allowing the tire to slip within hours of mounting.

1. **For new tire and wheel assemblies, clean the tire beads of any manufacturing related lubricants with an approved rubber cleaner fluid commonly used in the tire repair process.**
2. **Clean the wheel bead seating area.**

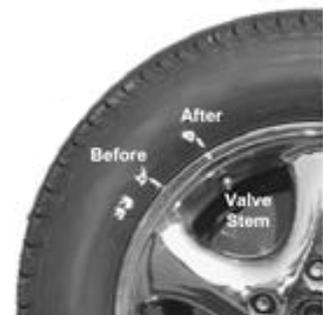
All of the test tires, regardless of brand or driving mode, slipped on the rim causing the assemblies to go out-of-balance. Toyo confirmed the results with several tire shops that monitored tire/rim slip by indexing the valve stem to the tire sidewall. One shop reported 3 inches of slip 12 hours after mounting and balancing resulting in a ride complaint.

3" slip after mild driving
(over)

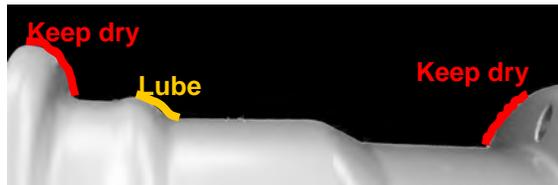
High performance, low profile passenger tires mounted on European-made alloy wheels may require higher mounting pressures, as bead seat tolerances may be tighter than domestic wheels. Additional lubrication of the safety hump (as shown below) may be required to facilitate bead seating.

4. **If more than 40 psi is required to seat the beads, dismount the tire, re-lubricate and repeat the process. Always follow the advice of the tire and wheel manufacturer regarding maximum pressure.**
5. **Index the wheel valve stem to some location on the tire sidewall so that slippage can be confirmed in the event of a customer return for vibration.**
6. **In the event of a customer complaint where tire/wheel slip has occurred, remove the old weights and re-balance the assembly. Do not dismount the tire unless there is a requirement to match-mount the assembly.**
